PFAS Investigation at a Rural Naval Airfield

Presented By
Angela Jones, PE
Naval Facilities Engineering Command (NAVFAC)
MIDLANT

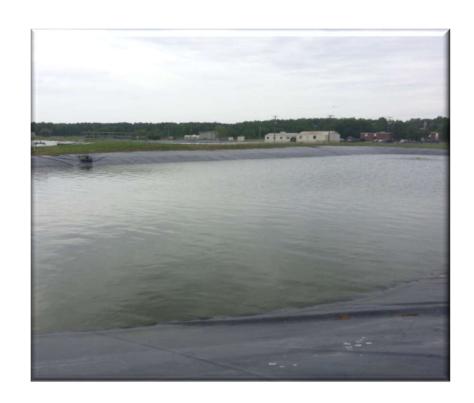
Sludge evaluation

Wastewater storage lagoon

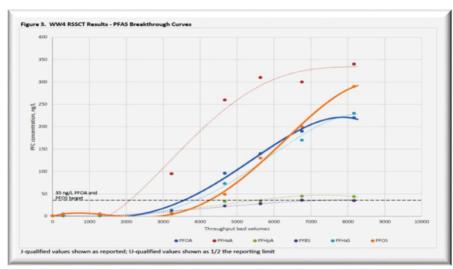
- GAC selected to treat potable water and wastewater
- Treatability for Drinking Water
 - Multiple GACs isotherm tested with Rapid Small Scale Column Testing
 - Finished drinking water,
 breakthrough >16,000 bed volumes
- Treatability for Wastewater
 - Alum and ferric sulfate pretreatment, 50 mg/L alum selected
 - Alum pretreatment reduced concentrations of PFOA (22%) and PFOS (56%)
 - Breakthrough for wastewater considerably sooner than drinking water due to TOC

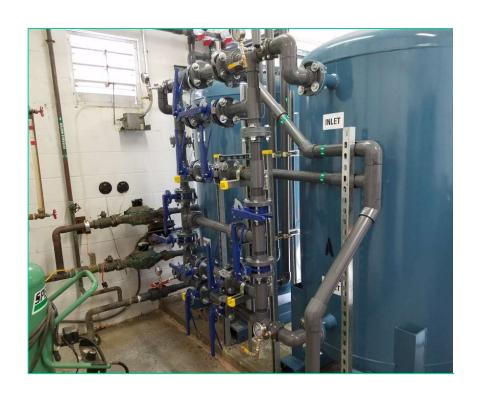
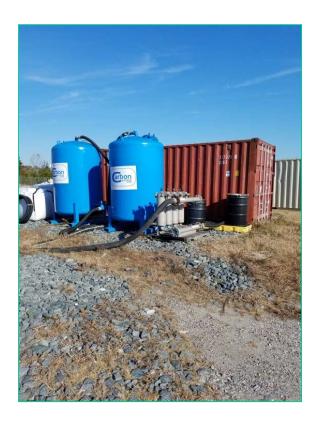
Treatment System Retrofits

- Drinking water system
 - Designed GAC systems on- and off-base using Filtrasorb 600
- Wastewater system
 - Sacrificial GAC prior to Filtrasorb
 400 treatment
